**M.C. Poyner House
219 Shingle Landing Road
Moyock, NC 27958**

Local Landmark Report

Historic Name of Property
M.C. Poyner House

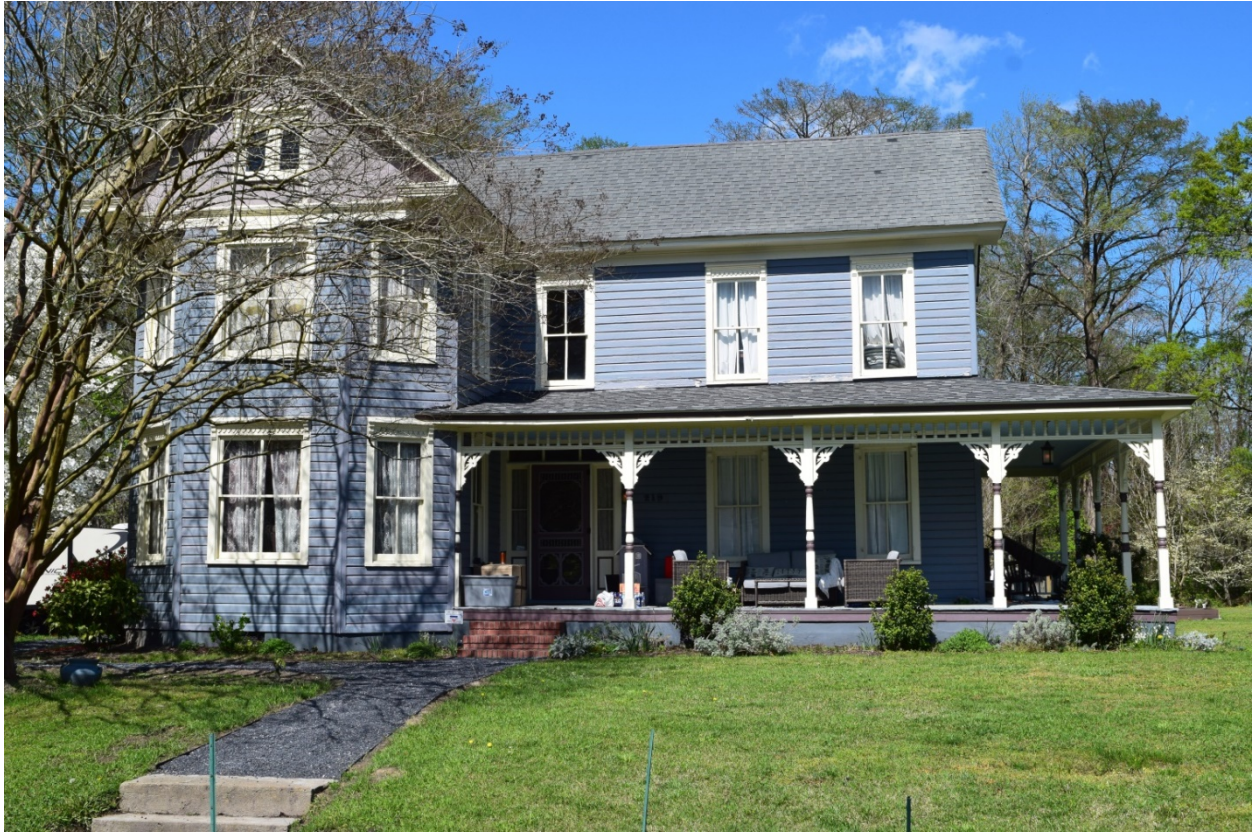
Fig. 1: Front (Southwest) Elevation

The M.C. Poyner House is two-story, side facing, T-shaped with a cross gabled roof and a one story hipped porch that wraps around the front façade and the southeast facing façade. The front façade faces Shingle Landing Road and features a two-story projecting gabled bay block to the left (northwest) of the main entrance; the six-panel wood front door is tucked under the hipped unenclosed, wraparound porch and it features a detailed replacement wooden storm door (Fig. 1). The front door features side lights on each side and a transom; under the side lights on each side is a rectangular molded wooden panel (Fig. 2). There are two symmetrical rectangular side lights above the panel on each side of the door and a transom over the door includes three rectangular lights (Fig. 3). The two-story projecting gabled bay block features a

gable end with molded cornice and returns with centered paired single-light hinged windows with molded drip hoods, saw tooth ornament, and scrolled brackets. The gable pediment features cut wooden strips installed in a sunburst pattern. The sunburst pattern was achieved by installing the wood strips diagonally on each side of the paired, single-light hinged windows and installing the wood strips vertically above and below the windows. Trim boards extend from the outermost vertical trim board of each window to the molded cornice of the gable. At the bottom corners of the gable end are brackets of an unusual style (Fig. 4). The brackets have turned Eastlake style details. The two-story projecting bay block features three bay 2/2 windows on each floor with the same window trim of molded drip hood, saw tooth ornament, and scrolled brackets. The southeast facing wall of the front gable block includes one 2/2 window on the second floor and one 2/2 window on the first floor under the hipped wraparound porch, both windows feature the same original trim (Fig. 5). Above the front door and wraparound porch on the second floor are three windows (2/2) with the same original window trim detail. One window is over the front door, and the other two are in line with the windows on the first floor wraparound porch. To the right of the front door under the wraparound porch are two windows (2/2) directly below each window on the second floor. The wraparound porch features a spindle frieze and pierced brackets; there are four turned spindle porch posts on the front façade and eight decorative brackets (Fig. 6, Fig. 7 & Fig. 8). The porch includes molded trim under the outermost edge of the wood tongue and groove porch flooring (Fig. 8). The entry consists of three brick steps directly in line with the front door. Leading up to the front steps from the road is a narrow gravel path.

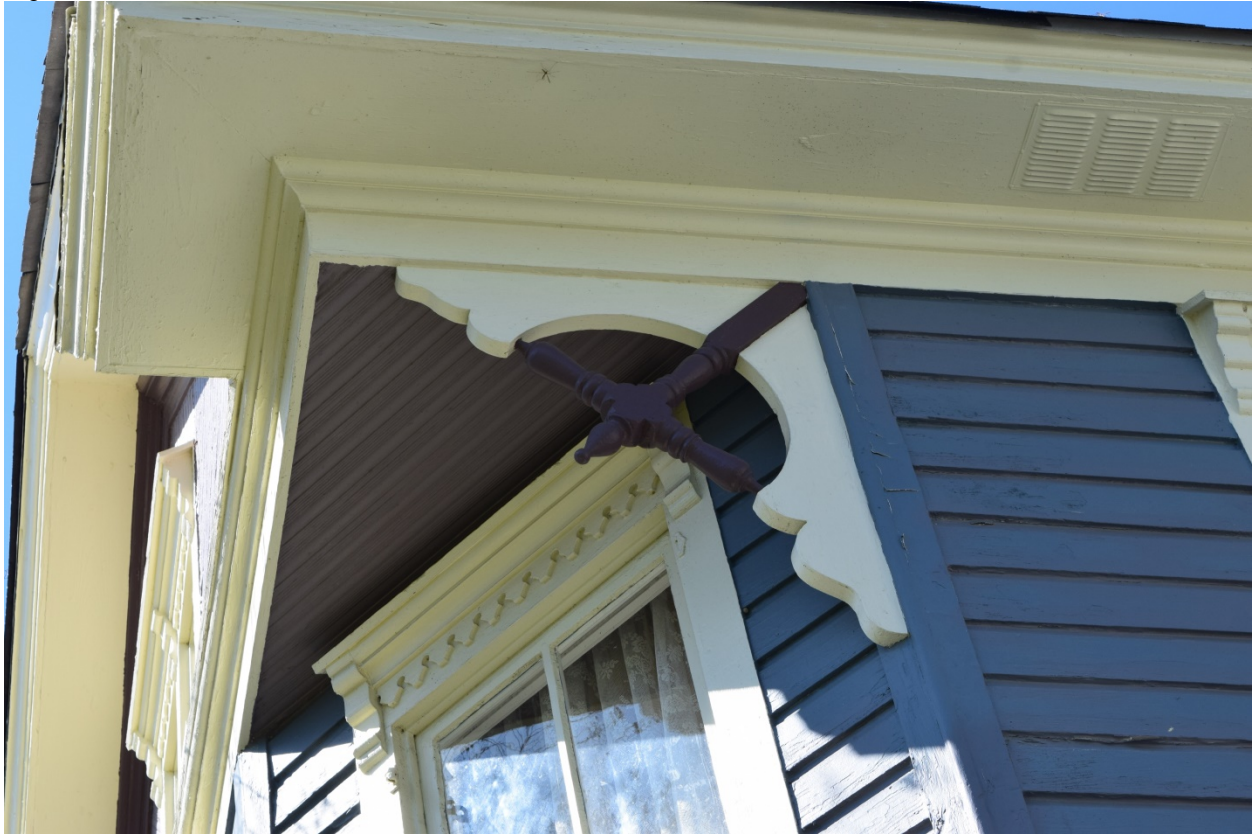
Fig. 4: Bracket under Front Gable

pierced brackets, and an unusual bracket style underneath the corner edges of the projecting two-story, front-gabled bay block.⁷

The M.C. Poyner House has delicate turned porch supports, spindlework frieze ornamentation on the wraparound porch and unusual spindlework detail on the brackets under the front wall overhang by the cutaway bay windows. These are all indicative of the spindlework decorative detailing subtype of the Queen Anne Style.

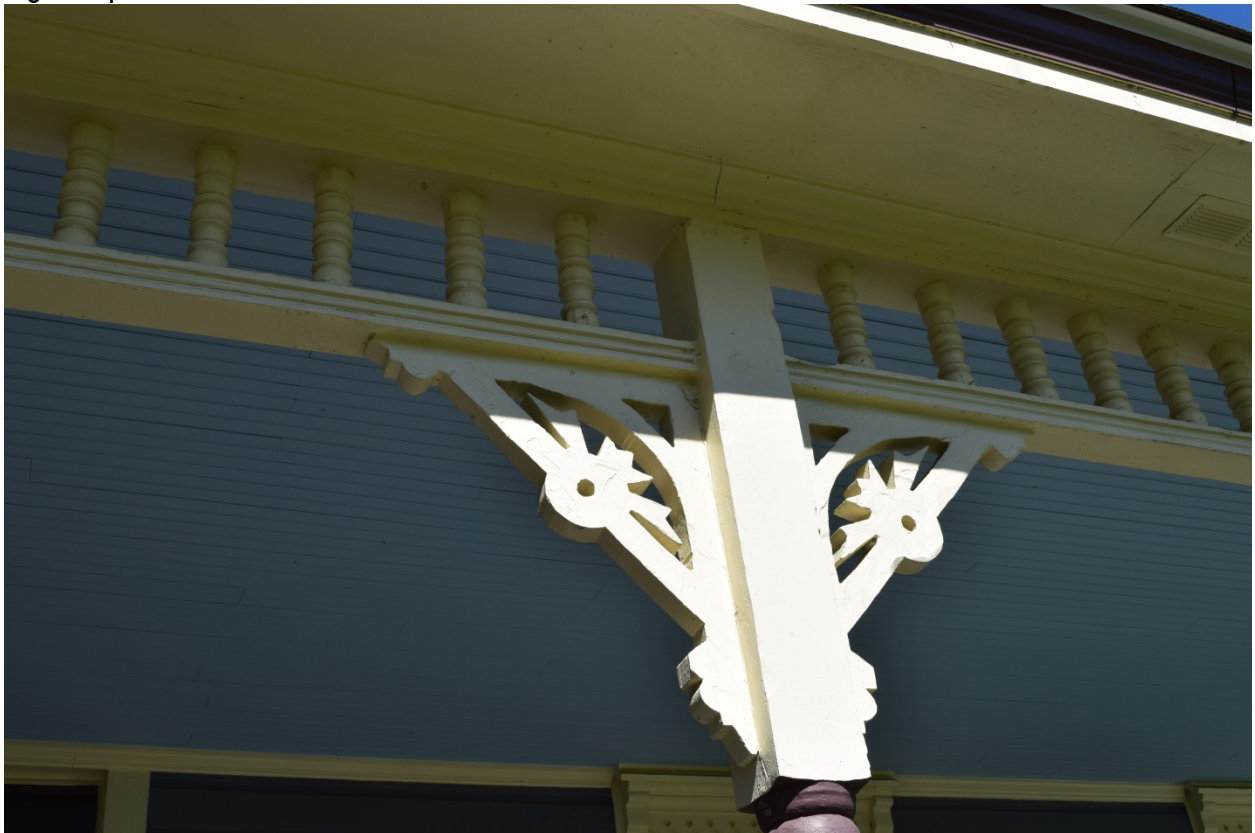
Fig. 7: Spindle Frieze and Brackets

The M.C. Poyner House is stick-built, 2,059 square feet, T-shaped, with a slightly projecting two-story front-gable roof bay block with cutaway bay windows on the front façade. It exhibits Eastlake influence and Queen Anne exuberance including a hipped wraparound porch with a spindle frieze and unusually detailed milled and

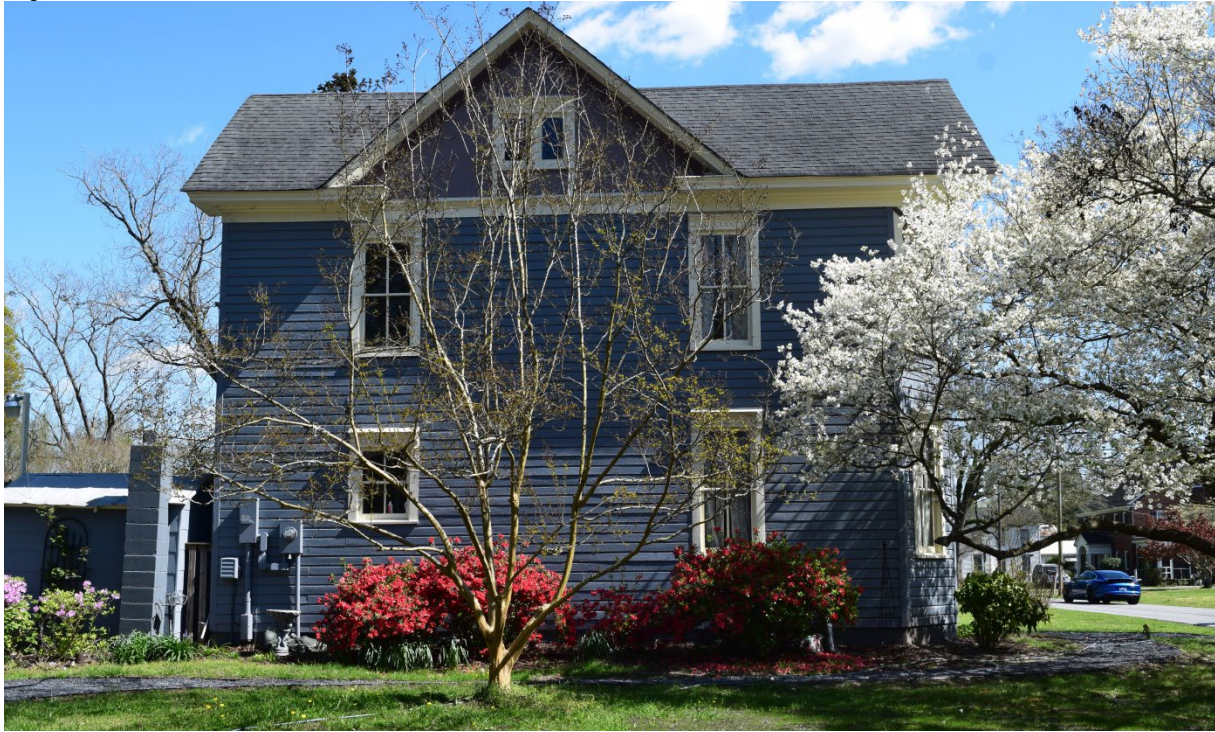
Fig. 9: Northwest Elevation

The northwest façade is the widest, flattest elevation of the house (Fig. 9). It features a nearly centered (slightly to the east) gable and the same gable-end style as the front and south façade with molded cornice, molded returns, the starburst patterned stick work, and paired, hinged, single light windows with molded drip edge, sawtooth ornament and scrolled console like brackets. There are two windows (2/2) on the second floor below each gable return. The first floor has a 2/2 window below the western second story window. The northeastern most window of the first floor is 2/2 but smaller and more square, this window was shortened in 1960 when the library became the kitchen. The kitchen window is located below the northeastern most second story window. All original windows have the same window trim previously described (Fig. 10 & Fig. 11).

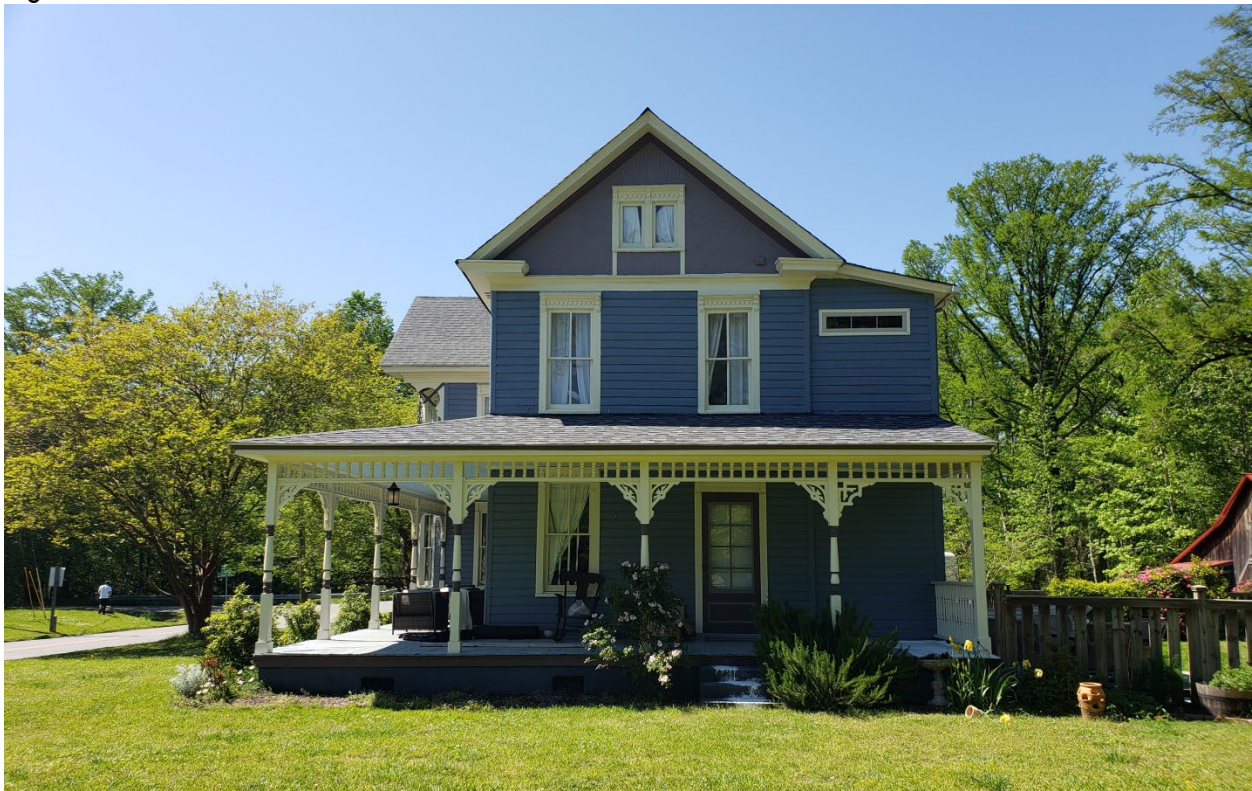
Fig. 12: Southeast Elevation

The southeast façade features a gable end and hipped wraparound porch (Fig. 12). The wraparound porch includes four turned posts (including the corner post that is shared by the front elevation) and six pierced brackets consistent with those of the front elevation (Fig. 13). The easternmost post of the porch is square, not turned, and the two brackets under the spindle frieze match those found on the second story porch of the northeast elevation (Fig. 14). The gable end features the same style, trim and

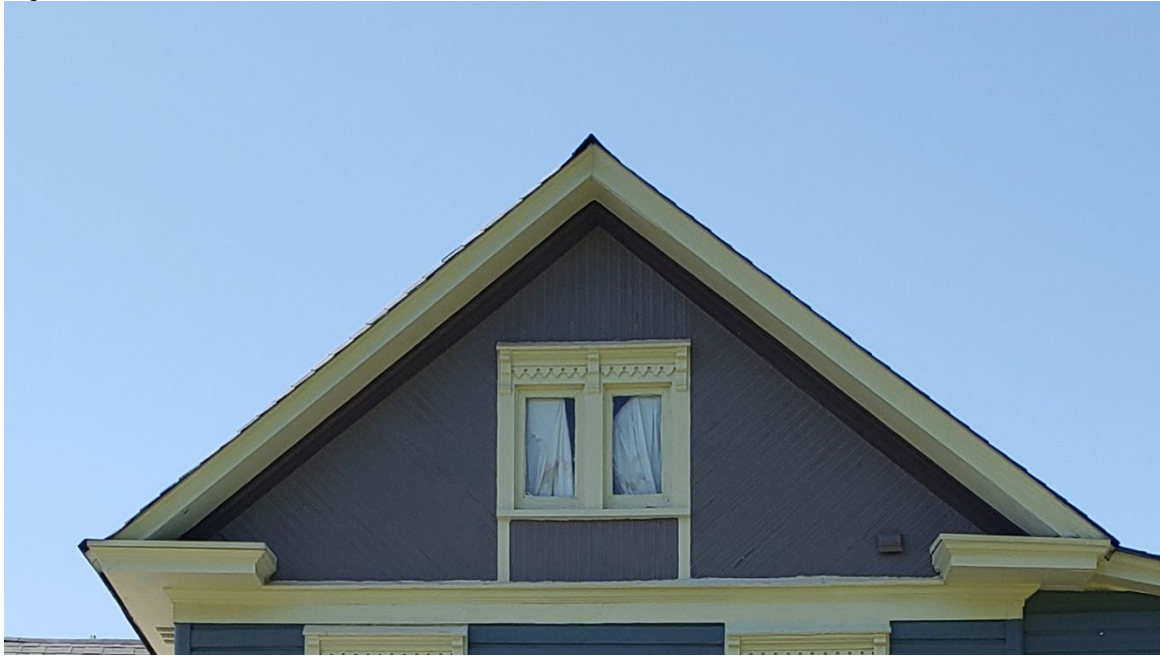
Fig. 15: Gable End

hinged paired single light windows with the same original window trim previously described (Fig. 15 & Fig. 16). On the second floor façade, below the gable end, inside of each gable return are two 2/2 windows with the same original window trim previously described. On the first floor, there is a 2/2 window below the southwestern most second floor window and a door below the northeastern most second floor window. The door is wooden and it features eight square divided lights and the door trim is the same trim used on the original windows previously described (Fig. 17). On the second story, a shed roof extends (slightly recessed from the exterior wall) from the gable eave to the northeast to cover what was a second story porch (slightly recessed). This portion of the house is enclosed with similar siding to the original and includes one narrow, horizontally installed vinyl window. Below the enclosed porch on the first floor the wall has the typical cladding and no windows and is also slightly recessed from the wall of the first floor.

The north, south, and west gable ends of the building are highly ornate with molded cornice and returns, narrow, diagonally cut wood strips arranged in a pattern that simulates a sunburst, and paired, single light, hinged windows. The sunburst pattern was achieved by installing the wood strips diagonally on each side of the paired, single-light hinged windows and installing the wood strips vertically above and below the windows. Trim boards extend from the outermost vertical trim board of each window to the molded cornice of the gable. The gable windows have molded drip hoods, scrolled, console-like brackets and sawtooth ornament.⁸

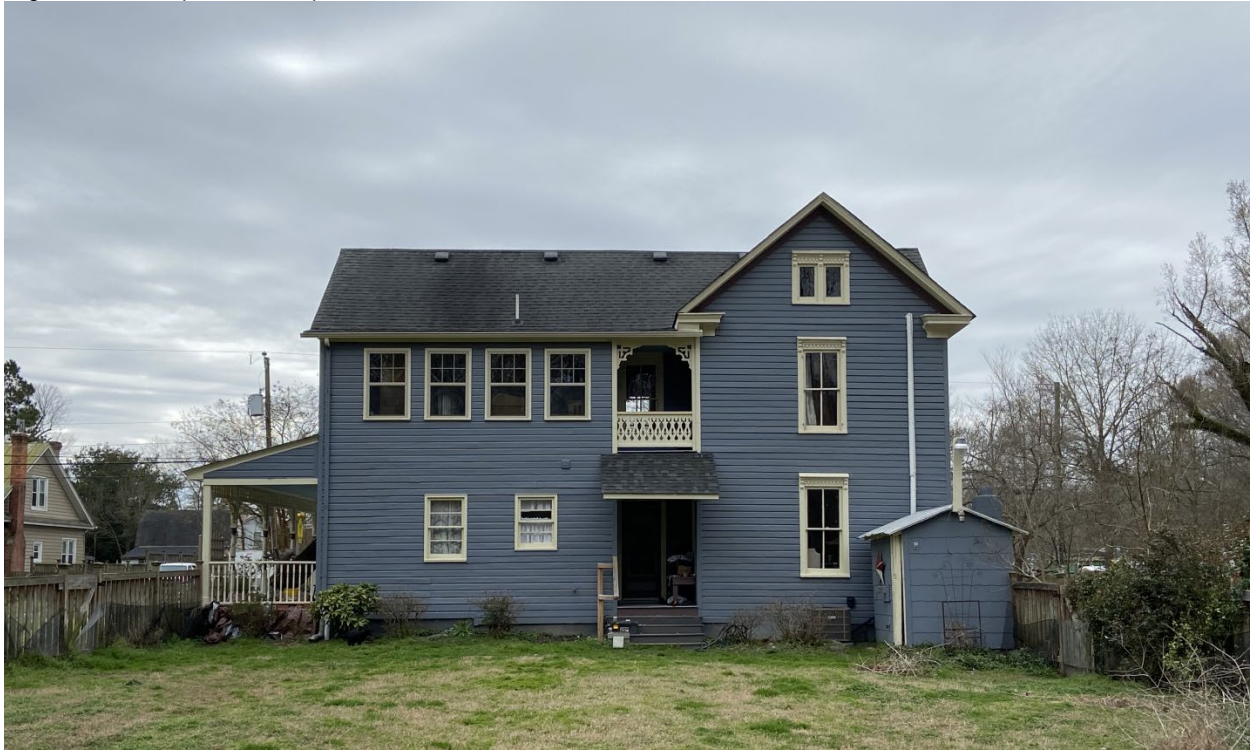
Fig. 18: Rear (Northeast) Elevation

The northeast façade (rear elevation) features the rear T gable, the gable end does not repeat the sunburst pattern, the pediment is horizontal siding (Fig. 18). The gable end does not feature a molded cornice but it does feature molded returns and the same centered paired single-light hinged windows with molded drip hoods, saw tooth ornament, and scrolled brackets. Under the paired single-light hinged windows of the gable end, are centered 2/2 windows on the second and first floor. To the southeast of the gable end and wall on the first story is a rear entrance covered by a shed style roof with asphalt shingles. Above the covered rear entrance, approximately the same width (4') is the remaining balustrade and decorative brackets of the original second floor porch (Fig. 19). To the left of the remaining porch opening and balustrade are four six over one vinyl windows, the windows are not original and do not have notable trim. The enclosed porch includes similar siding as the original. Under the enclosed porch on the first floor are two windows with 2/2 horizontal panes, the window on the right is smaller than the one on the left. The end of the wrap around porch is cladded and the features a spindle railing.

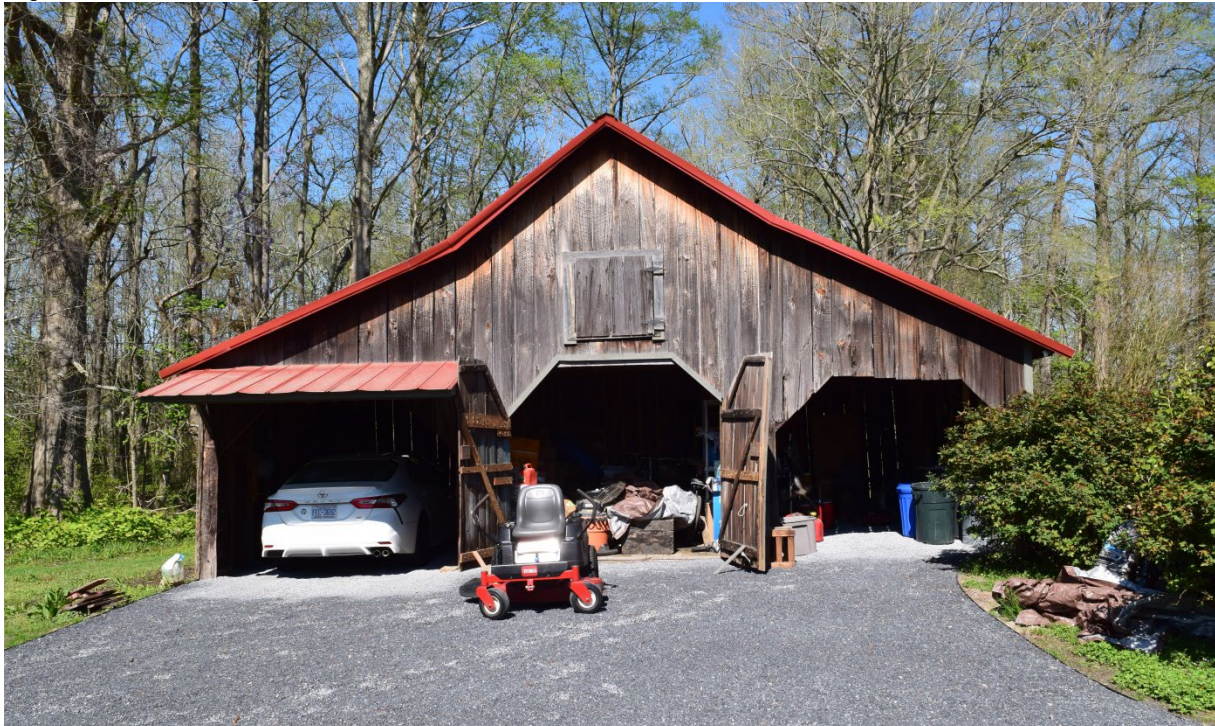
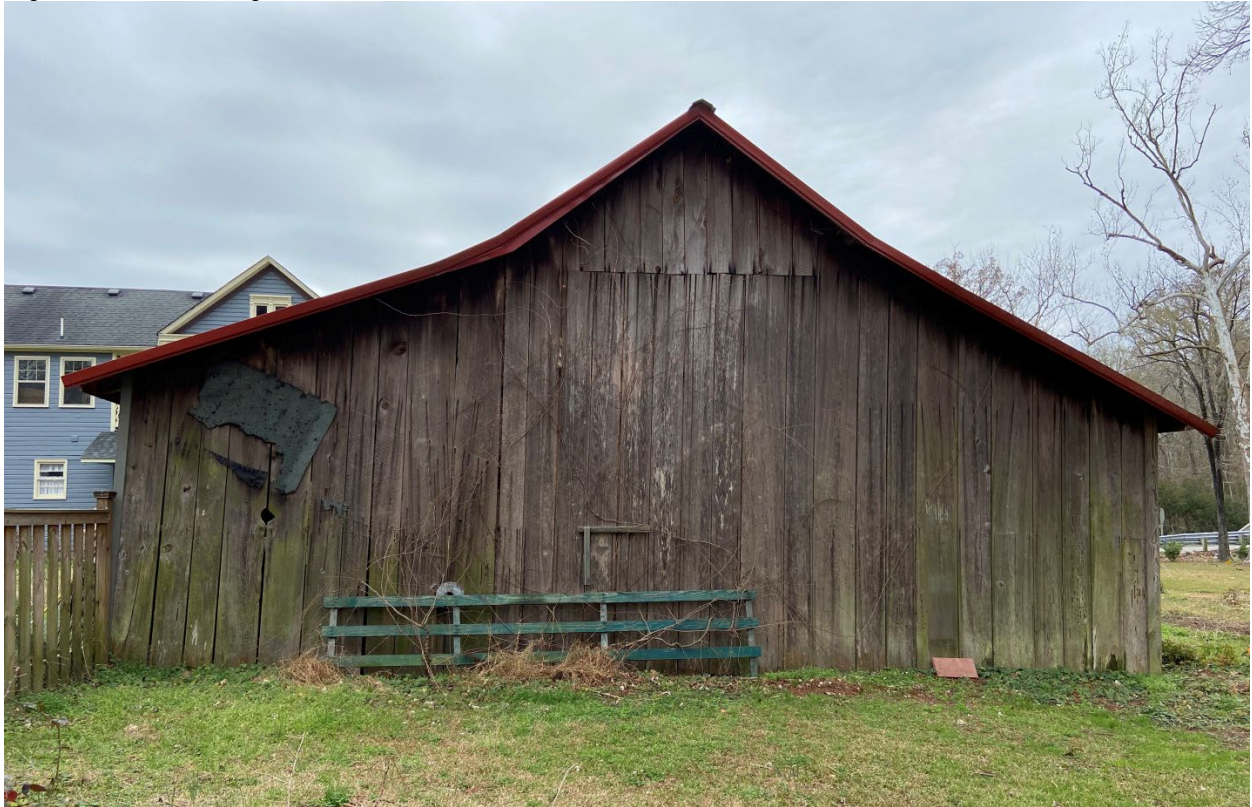
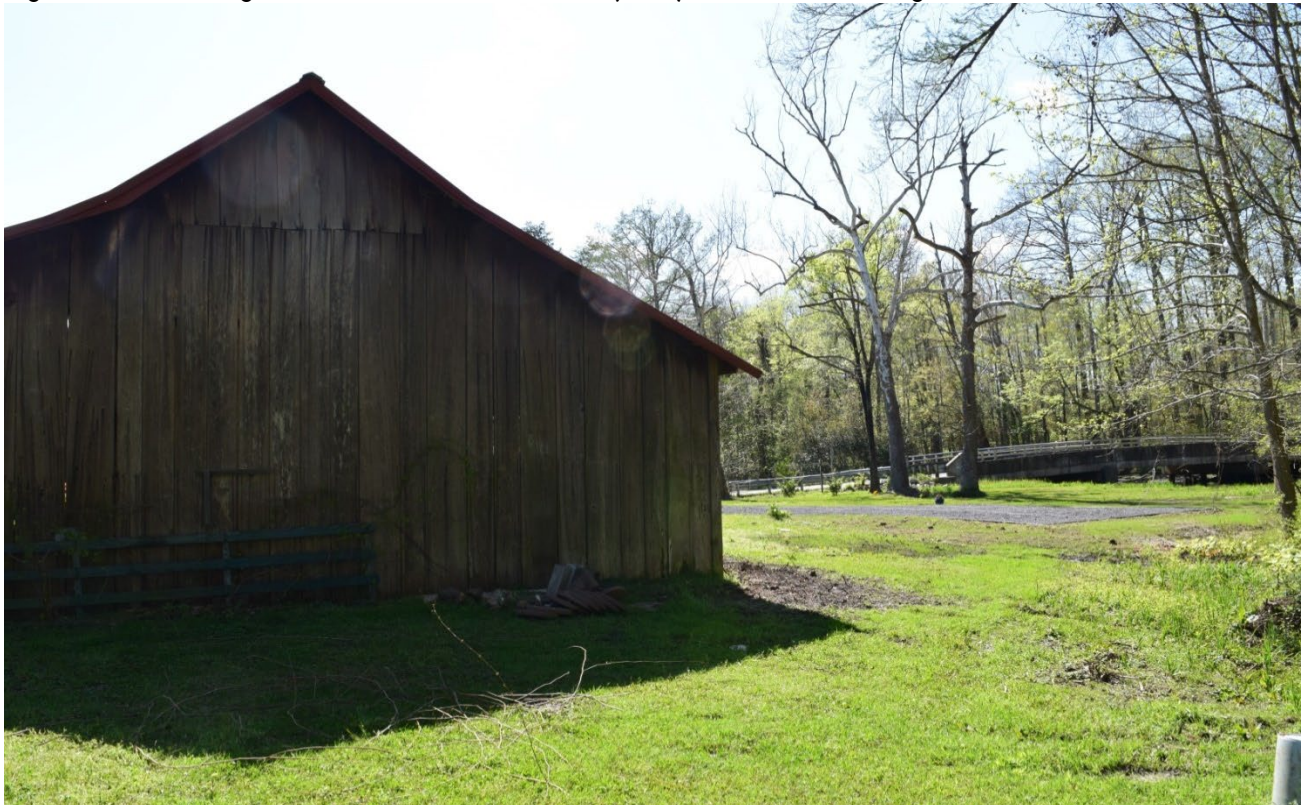
The property includes a two story tin-roofed wooden barn that was built at the same time as the house and is the only other remaining building of historical importance within the property's boundary (Fig. 21, Fig. 22 & Fig. 23). The barn sits to the rear (northeast) of the main house. The barn consists of three bays and a hayloft with cutout door in the gable over the middle bay. All sides of the barn are sided with no additional openings.
